SANDIA REPORT

SAND88-3341 • UC-25
Unlimited Release
Printed April 1989

Did High-Altitude EMP Cause the Hawaiian Streetlight Incident?

Charles N. Vittitoe

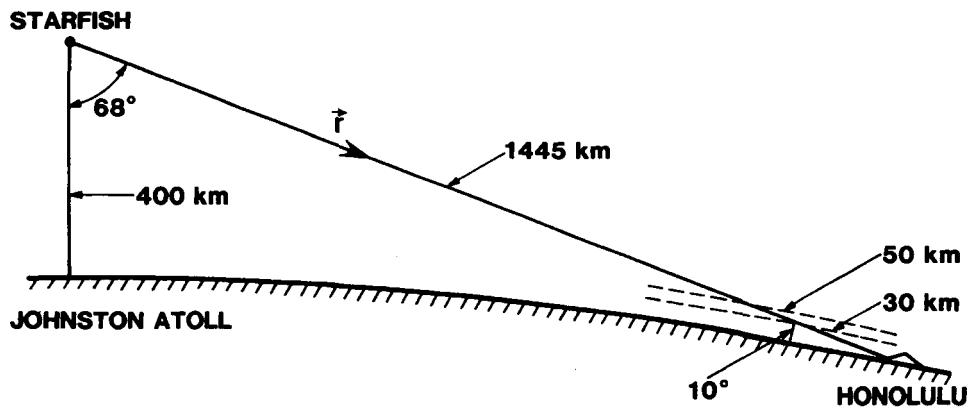
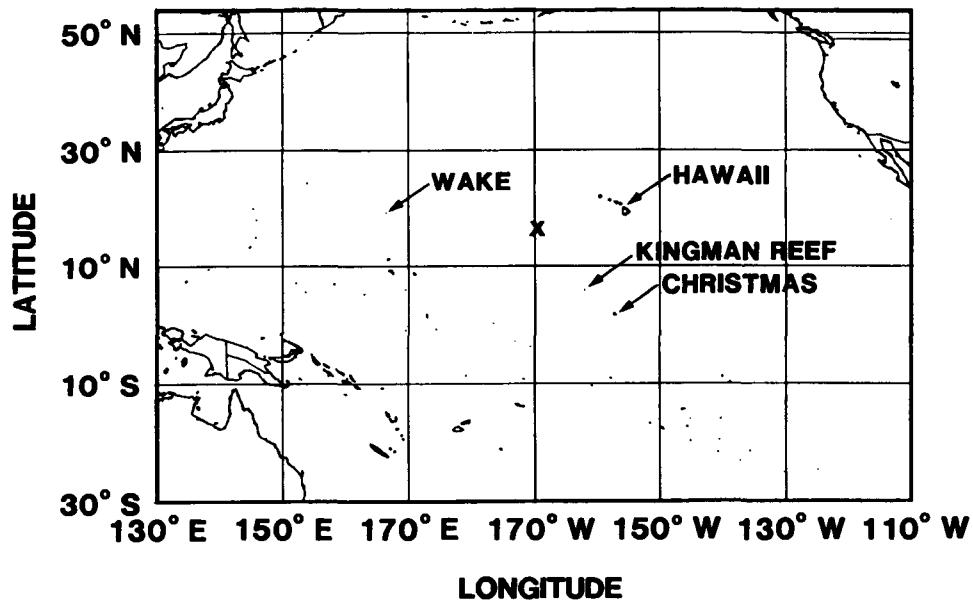
Here we examine the streetlight incident and test for consistency between the observed effects and those expected from limited analysis. If the EMP interaction with the lights was too small to have caused damage, the “best authenticated case” would be dismissed and the EMP would lose stature as a threat. If the EMP interaction was large, then all the lights would have been damaged. Since that did not occur, the EMP would again lose stature as a threat. Because of these rather narrow limits and the lack of many data points, because of the wide publicity attained, and because of the diversity in views concerning EMP, the streetlight incident is a crucial verification of the EMP threat to civilian systems. The geometry of the burst is shown in Figure 1.

**BURST 30 km SW of J.A.
AT 16° 28' N, 169° 38' W**

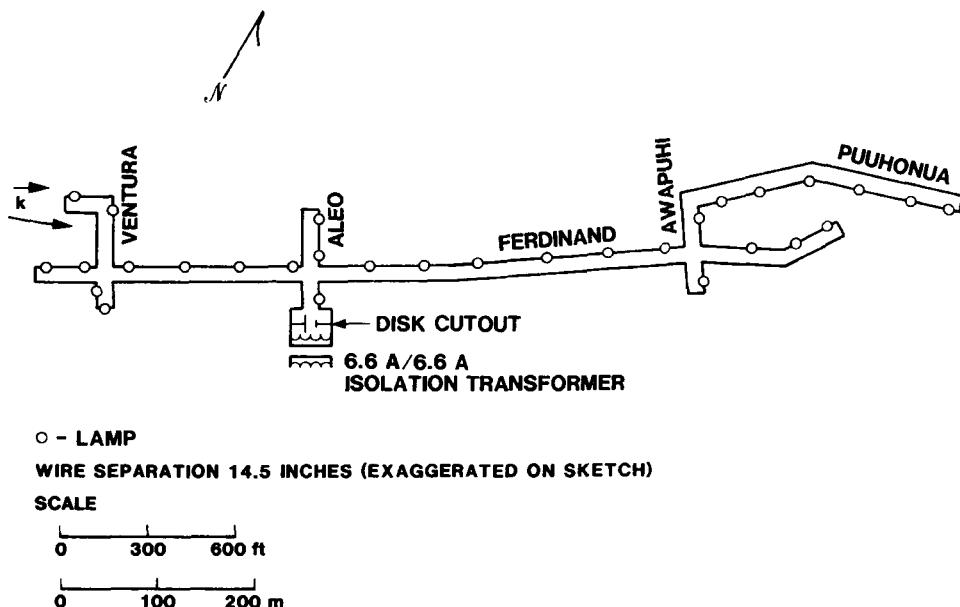
Figure 2. Ferdinand Street series lighting system in 1962

John Mattox⁵ provided the data for Figure 2 on one streetlight loop that suffered damage: the Ferdinand Street loop in Manoa. His information was based on field work in Hawaii, on discussions with streetlighting personnel, and on the newspaper accounts. Some 30 strings of streetlights failed, about 1% of the lights existing at the time. The failure of 30 strings was well beyond any expectations for severe storms (where ~4 failures were typical). He concludes that the failures are definitely associated with the Starfish explosion.

The lighting circuits were 6.6-A series circuits, with each incandescent bulb protected by a small disk cutout (fuse) in parallel with the base of each lamp. The small disk cutout provided continuity when a filament failed. Typically, 50 to 90 V across the filament leads caused a spark that created a shunt path through the cutout. These cutouts were about the size of a dime. When such failures occurred, the circuits were repaired by replacing the filament (the bulb) and the disk cutout. However, none of these small disk cutouts for individual streetlights were responsible for the failures recorded. Larger disk cutouts in another part of the circuit were responsible for the streetlights going out.

Mattox found drawings of part of the series lighting system, retained by the City of Honolulu and reproduced as Figure 2. The circuit was basically a 3000-ft-long (914 m) horizontal loop that was 14.5 in. (36.8 cm) wide. The loop was not grounded and was activated by a 6.6-A isolation transformer. Wiring details are ambiguous at intersections such as where Puuhonua and Ferdinand come together in Figure 2. The wire with the streetlights on Ferdinand Street

The secondary, 500-V #6-gage medium-hard-drawn copper line typically held ~20 lamps, to furnish 25 V per lamp.⁷ Circles in Figure 2 represent 30 lamps. Thus, this circuit was a 750-V line, the maximum voltage allowed at the pole position where the secondary loops were mounted. Figure 2 shows a 2-wire system where the return wires are located on the same poles as the lights. About 80% of Honolulu used such a system. The rest used a single-wire system, where much more area was enclosed within the loop. No preference was obvious for damage to occur on either type of system.

The idealized geometry of a single two-wire transmission line is expected to give an upper bound to the line voltage. Figure 2 suggests that rather than the propagating transmission-line voltage, the effective voltage charging the disk cutout is likely to be a smaller value. As a rough estimate, the junction at the disk cutout in Figure 2 might be viewed as a voltage divider. The propagating pulse would see three outgoing, two-wire transmission lines with the same 14.5-in. spacing. The equal characteristic impedances would reflect $\rho_i V_{inc}$ of the incident $V_{inc} = 10 \text{ kV}$, where $\rho_i = (3Z_o - Z_o)/(3Z_o + Z_o) = +1/2$. The transmitted voltage was divided by 3, giving 1700 V across the disk cutout. The corresponding transmission-line current is $1700 \text{ V}/Z_o$. From Appendix B, Z_o is $120 \ln(d/a) \Omega$. With $d = 0.368 \text{ m}$ and $a = 0.002058 \text{ m}$, $Z_o = 620 \Omega$ and the differential-mode peak transmission-line current that branched toward the disk cutout was 2.7 A.

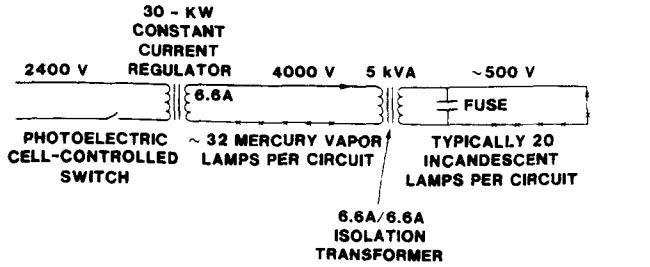
Figure 3. Typical lighting network for loop driven by the isolation transformer

The data indicate that about 30 strings of streetlights went out on Oahu and most of the circuits were in Honolulu. Records (no longer available during the Mattox search) show repair work on July 9, 1962. Watson gives a diagram (Figure 3) of a typical lighting network for loop driven by the isolation transformer.

In Figure 3, the utility-company line furnishes power to the constant-current regulator by means of a photoelectric-cell-controlled switch. The 2400 V at the regulator is provided by a phase-to-neutral connection on the incoming 4160-V (phase-to-phase), 3-phase, 4-wire, wye-connected utility power. The electric power community refers to this incoming line as a 4-kV line. However, we will call this incoming line a "2400-V" line and reserve "4000 V" to refer to the line so labeled in Figure 3.

FUSE IS SOURCE OF DIFFICULTY, STARFISH - ASSOCIATED, JULY 8, 1962
23 REPORTED REPLACEMENTS ON JULY 9, 1962
O NORMAL

The 30-kW regulator in Figure 3 with the 6.6 A it provided indicates that the power source for the labeled 4000-V line could furnish up to 4.5 kV. The utility distribution equipment that provided power to the 2400-V line had a 60-kV BIL rating (basic impulse insulation level, a measure of lightning protection) and suffered no damage. It is likely that the current regulator with its 6.6-A secondary driving the 4000-V series line also had a 60-kV BIL rating. The 4000-V and 500-V labels should not be considered as fixed values. The current regulator was often set at 6.5 A rather than 6.6 A to prolong lamp life. Once set, the current was regulated and fixed (except for transients caused by electromagnetic interference). The voltages varied somewhat, depending on the number of streetlights in the circuit.

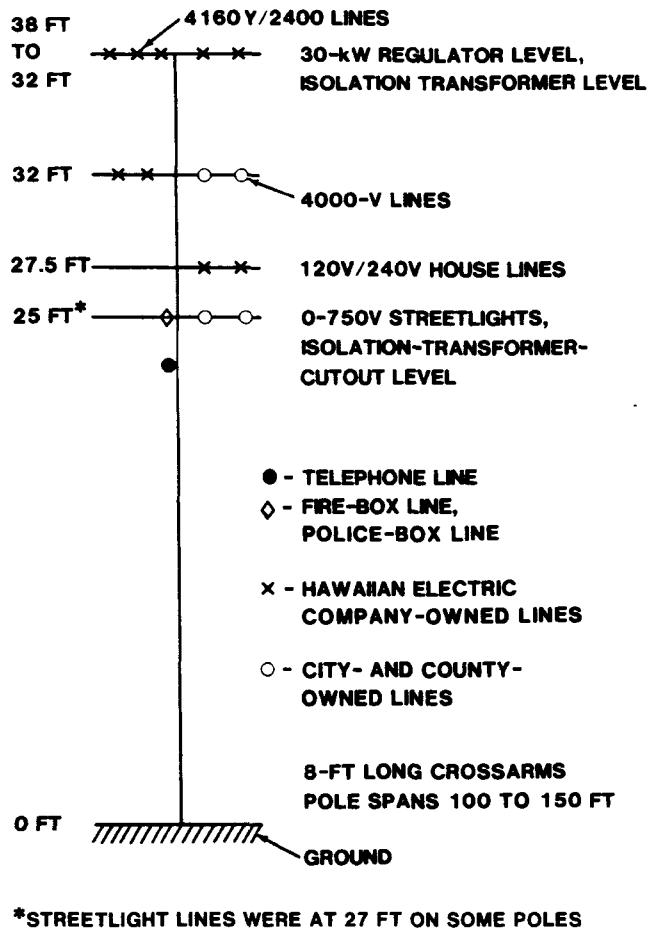
Figure 4. Typical pole arrangement for loops driven by the isolation transformer

The 4000-V lines typically had ~28 mercury vapor lamps plus perhaps two isolation transformers driving the incandescent-lamp secondary circuits of the type that failed. Each 400-W mercury vapor lamp required ~1-kW driving capacity to provide the needed starting surge. The secondary isolated circuits were used at side streets characteristic of residential neighborhoods where short poles left no room for the 4000-V lighting systems. The only place where the 4000-V and 500-V lines had the arrangement in Figure 4 is where the isolation transformer made the transition from the primary to the secondary lamp circuit. The 500-V line proceeded from this origin to a series of shorter poles. Alan Lloyd indicated that the uppermost lines were reserved by Hawaiian Electric. The City-County lines at 4000 V and 500 V were at smaller heights, as indicated in Figure 4.

The lighting geometry diagrammed in Figures 2, 3, and 6 is idealized from that actually encountered in 1962. Figure 4 shows some of the neighboring wires that were likely to be present. Such neighbors help share the common-mode current, reducing that threat with no significant effect on the differential-mode voltage that caused the experienced damage.

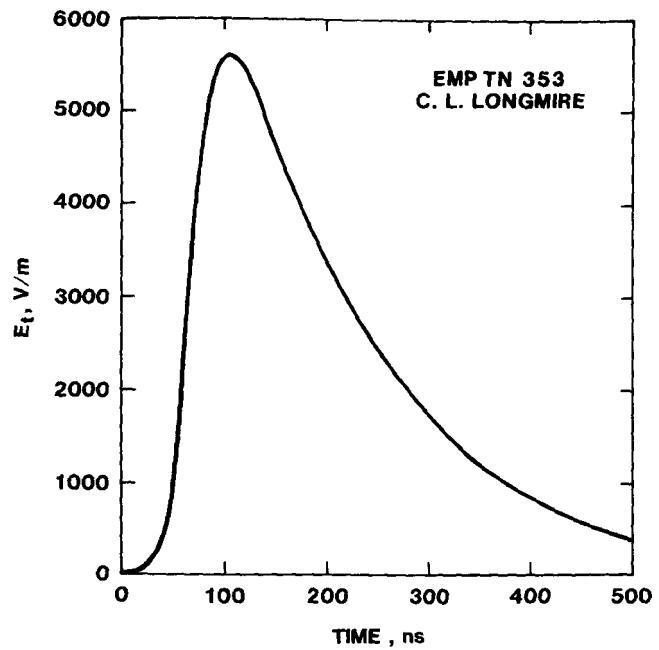
Figure 5. The high-altitude EMP generated by Starfish, as seen at Honolulu

Estimates are available for the early-time high-altitude EMP created by the Starfish burst and arriving at Honolulu.¹¹ The dip angle of the geomagnetic field in the gamma-ray absorption region was taken as 35°, with the observation point at 54.3° east of the magnetic north direction. Figure 5 shows the transverse EMP generated by the 1.4 kT of gamma rays (used in the calculations¹¹). The peak amplitude at Honolulu is 5.6 kV/m, with a 10% to 90% rise time of ~38 ns. As pointed out,¹¹ the pulse is not saturated and does not represent a worst-case pulse. Higher weapon yields and increased geomagnetic fields in the gamma-ray absorption region of the atmosphere (as would be experienced over the central US, for example) would result in larger peak EMP fields. Although Reference 11 does not provide an uncertainty for this incident EMP, simplifications in the Starfish output used in the calculation and in the EMP codes are judged to give accuracy within a factor of 2.

Aside from the early precursor, the rise to peak can be approximated by $5600 \text{ V/m} \sin[26.624 t(\mu\text{s})]$. This representation requires 59 ns to reach the peak and has the 38-ns rise time. The fall requires lower frequencies.

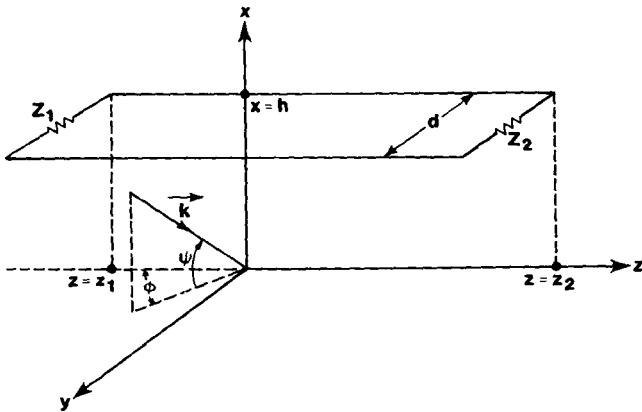
Figure 6. Incident-wave geometry for the transmission line

The lighting circuit is roughly modeled as a two-wire, straight transmission line of length p , with terminating impedances Z_1 and Z_2 at the two ends. The transmission line equations are developed in Appendix B. The incident EMP is treated as a plane wave, locally incident at Ferdinand Street and illustrated by the propagation vector \mathbf{k} in Figure 6.

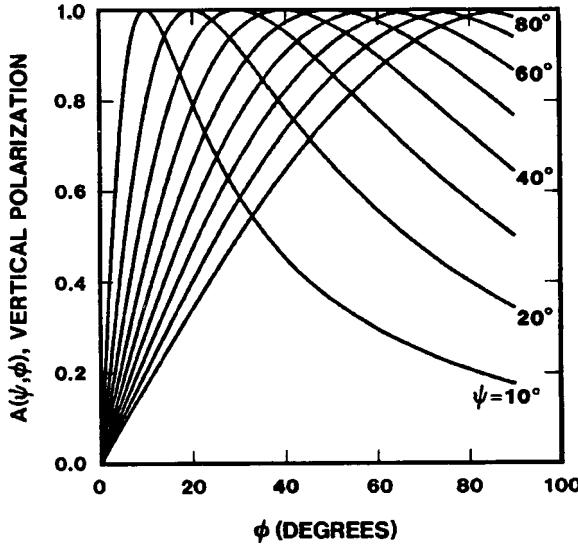
Figure 7. The angular factor $A(\psi, \phi)$ for transmission-line excitation by a vertically polarized incident wave

As discussed in Appendix B, this differs from Vance's directivity function,¹² that he evaluated for a single wire above a ground plane. The angular variations are shown in Figures 7 and 8 for the two polarizations. At given ψ in Figure 7, the peak occurs at $\phi = \psi$. The

term for vertical polarization is somewhat contrary to intuition. At $\psi = 90^\circ$, no magnetic flux threads the loop, and so zero coupling might be expected. However, $\phi = 90^\circ$ maximizes the E_y and its contribution dominates the voltage. At $\psi = 90^\circ$ in Eq (12) the vertical-polarization case degenerates to horizontal polarization. Yet $\sin \phi \neq \cos \phi$ for arbitrary values of ϕ . However, $\sin(90^\circ - \phi) = \cos \phi$, and the difference only reflects the definitions of horizontal and vertical polarization.

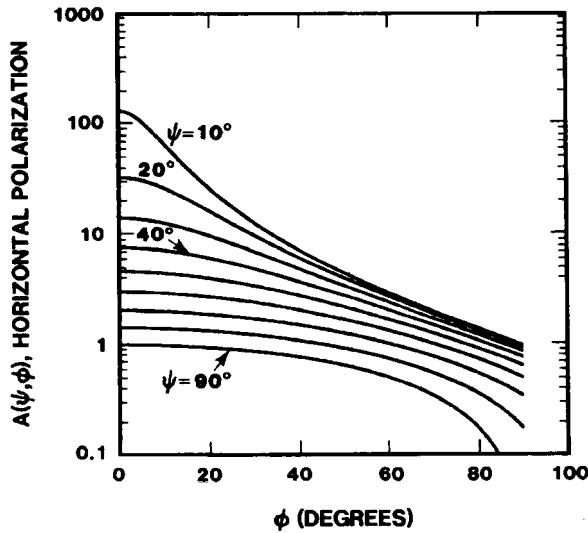
Figure 8. The angular factor $A(\psi, \phi)$ for transmission-line excitation by a horizontally polarized incident wave

The variation is more dramatic in Figure 8. The peak for horizontal polarization occurs at $\phi = 0$. At $\psi = 10^\circ$, the $\phi = 0$ gives a peak of 130; the peak falls to 14 at $\phi = 30^\circ$. The peak results from coherent addition of the transverse electromagnetic (TEM) signal propagating at speed c along the transmission line and the line excitation that travels at a phase velocity along the line that is $c/\cos \phi \cos \psi$. The closer the excitation and propagation speeds match, the greater the coherent addition. At $\psi = 0^\circ$ and $\phi = 0^\circ$, the large coupling for horizontal polarization should be modified by line and ground resistance effects that are neglected in Appendix B. The coupling is sensitive to the incident polarization.

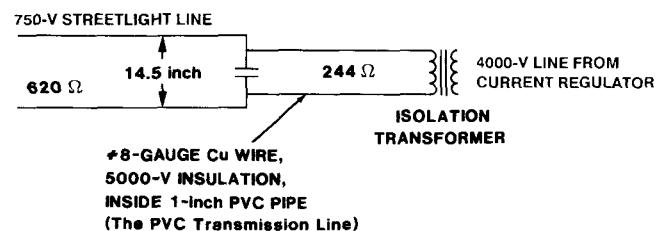
Figure 9. Transmission-line connections at the isolation-transformer disk cutout

The disk cutout is mounted on the crossarm that holds the streetlights, about 13 ft (4 m) below the isolation transformer. The geometry is indicated in Figure 9. The #8-gage wires are channeled inside a 1-in.-dia PVC pipe mounted along the pole and under the crossarm to the streetlight lines where the cutout is located. The incident peak of 1700 V sees the impedance discontinuity. A portion is reflected, leaving a smaller voltage incident on the parallel connection of the cutout and the PVC transmission line.

Estimating the wire separation within the PVC pipe at 1/2 in. (1.27 cm), the characteristic impedance of the line is $Z_{PVC} = 120 \cosh^{-1}(d/2a) = 244 \Omega$. The

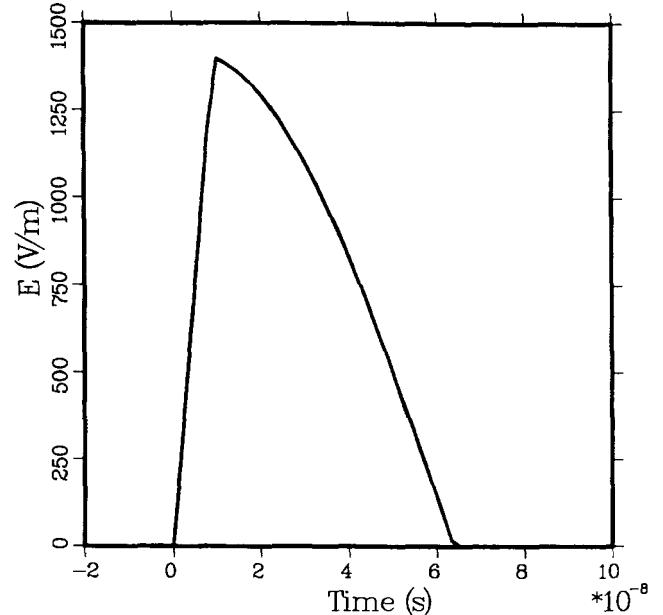
Figure 10. Incident EMP (at $\psi = 10^\circ$) that provides a horizontal component of electric field that includes the reflected-pulse contribution

A better approximation to the peak common-mode current is found by letting the integral extend beyond 9.5 ns. The first 9.5 ns of the incident pulse is taken as the $5600 \text{ V/m} \sin[26.624 t(\mu\text{s})]$ variation suggested for the rise in Figure 5. After a delay of 9.5 ns, the same pulse is subtracted, with the t replaced by $t - 9.5$ ns. At $t \geq 63.75$ ns the sum is taken as zero. The resulting pulse is illustrated in Figure 10. It represents a driving field with reasonable horizontal electric fields to include reflection effects (from a perfect reflection at the ground). Using the integral of this E^i out to 64 ns indicates that the peak

common-mode current is ~ 140 A. This value is consistent with estimates from the TWTD computer code,¹⁴⁻¹⁵ where current pulse widths were ~ 200 ns.

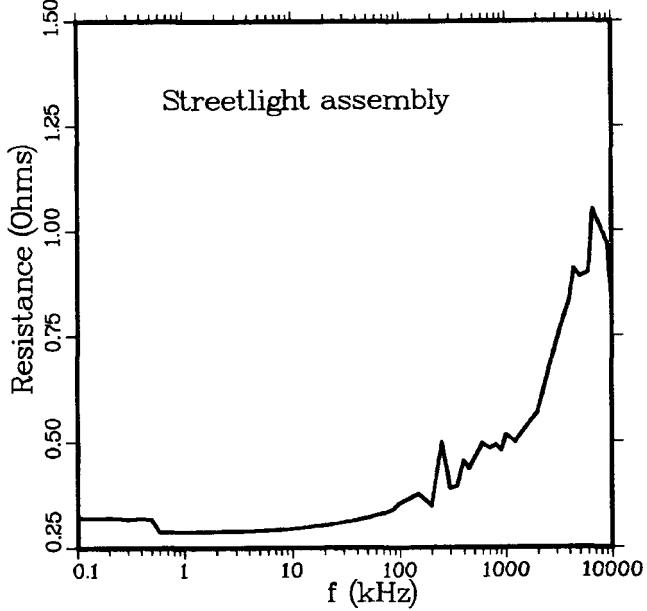
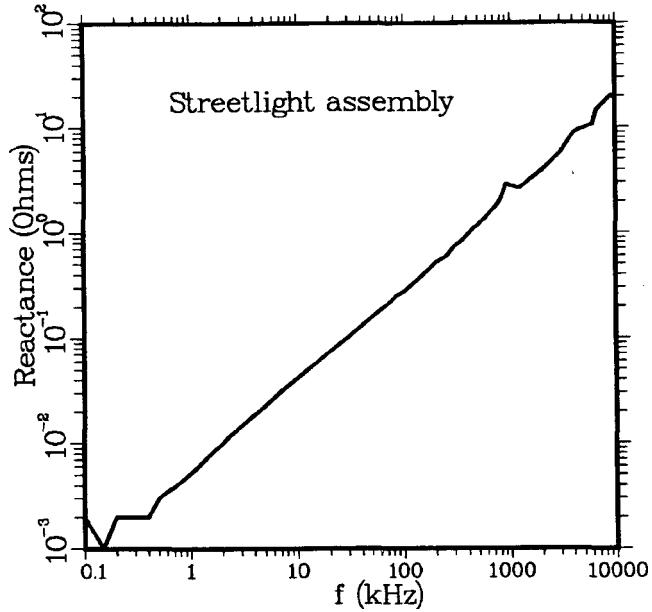
The streetlight assembly has a 2.2- by 7-cm clamp that holds the disk cutout. The clamp has an average separation of ~ 5 mm, giving an effective capacitance closer to $C = 15 \text{ pF} + \epsilon_0(2.2 \times 7 \times 10^{-4})/5 \times 10^{-3} = 18 \text{ pF}$. This is still not enough to form an effective shunt. Impedance measurements of the streetlight assembly that includes the lamp, its socket and the disk cutout are illustrated in Figures 11 and 12. The

resistance stays below 1Ω . It is assumed that at operating temperature this resistance rises to $\sim 3.3 \Omega$. The reactance remains inductive throughout the measurements shown in Figure 12. Division by ω gives the effective inductance shown in Figure 13. The L is roughly $1 \mu\text{H}$.

Figure 11. Real part of the streetlight-assembly impedance

Figure 12. Imaginary part of the streetlight-assembly impedance

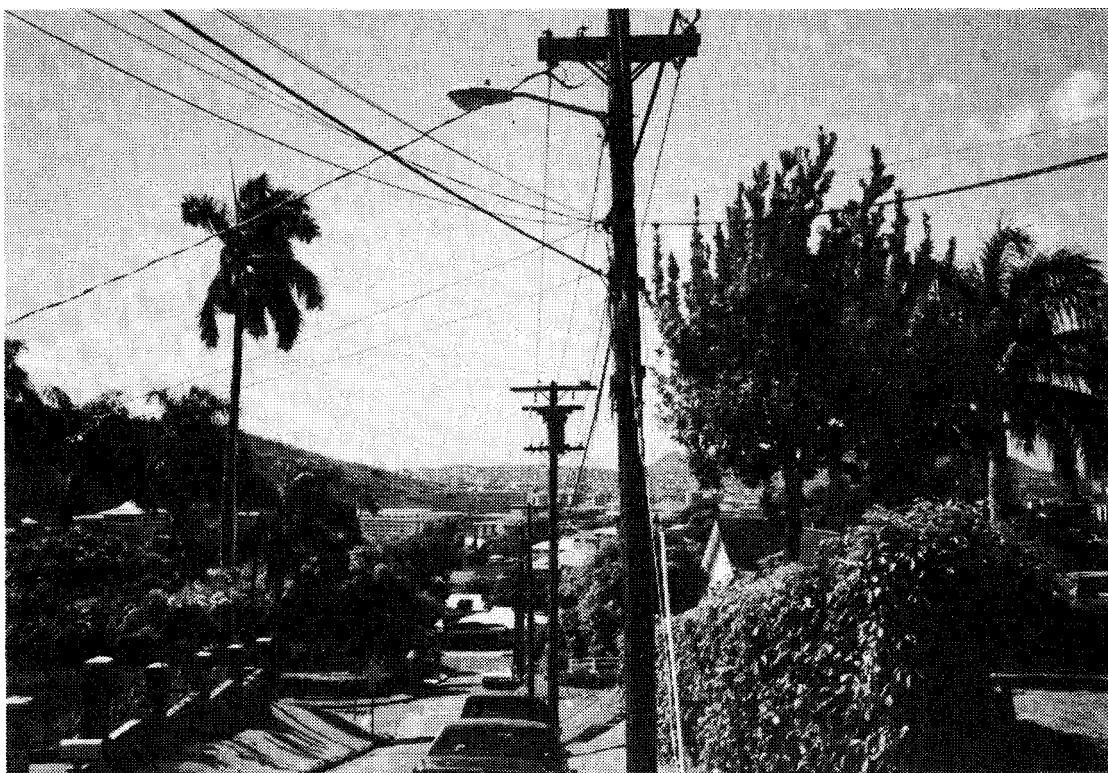
Figure 14. View along Aleo, southeast, toward Ferdinand

ization. Figure 14 shows a view toward the southeast taken from the deadend at Aleo in Figure 2. A modern streetlight is seen at the top of this July 1988 photograph. Less visible are the streetlights on the third and fifth telephone poles as you proceed along Aleo. The street between the third and fourth poles is Ferdinand. The streetlights seem to be arranged as they were in 1962 (illustrated in Figure 2). On close examination the poles show considerable wear; 25 years of service seem possible. Just beyond the third streetlight is where the isolation transformer and its disk cutout were located in 1962. Extra wires are present that are not accounted for in the analysis. Extra wires in 1962 cannot be accounted for.

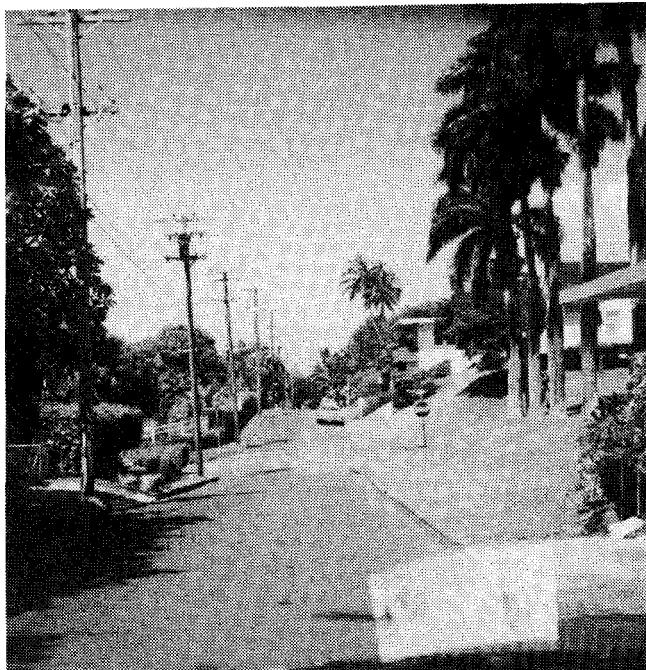
Figure 15. View along Ferdinand toward the Aleo intersection and toward Johnston Atoll

Figure 15 illustrates the view along Ferdinand Street toward Johnston Atoll. The stop sign is at the Aleo intersection. The gentle slope suggests that the elevation angle (with respect to the ground) was

larger than 10° . Some line drooping is also apparent between the poles. The wiring does appear more idealized than at the intersection and perhaps is able to support the coherent addition necessary for the cutout damage.

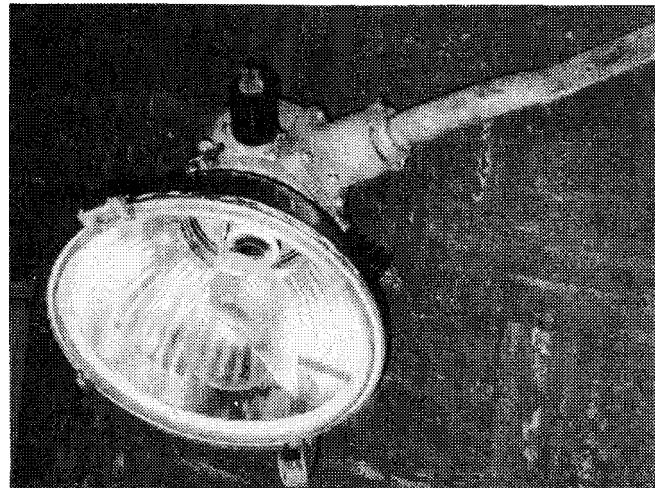
Figure 16. A 2500-lumen streetlight of the type used in 1962

One of the 1962-type streetlights with its 2500-lumen bulb is illustrated in Figure 16. The pipe was mounted to a telephone pole. Two glass insulators show where the series connections were made to the #6-gage streetlight wires. About 2 m of wire were necessary to make these connections. Such streetlights offered perturbations in the idealized geometry that gave the coherent signal propagating toward the isolation transformer and its disk cutout. These hardware considerations indicate some features of the 1962 system that have not been rigorously taken into account.

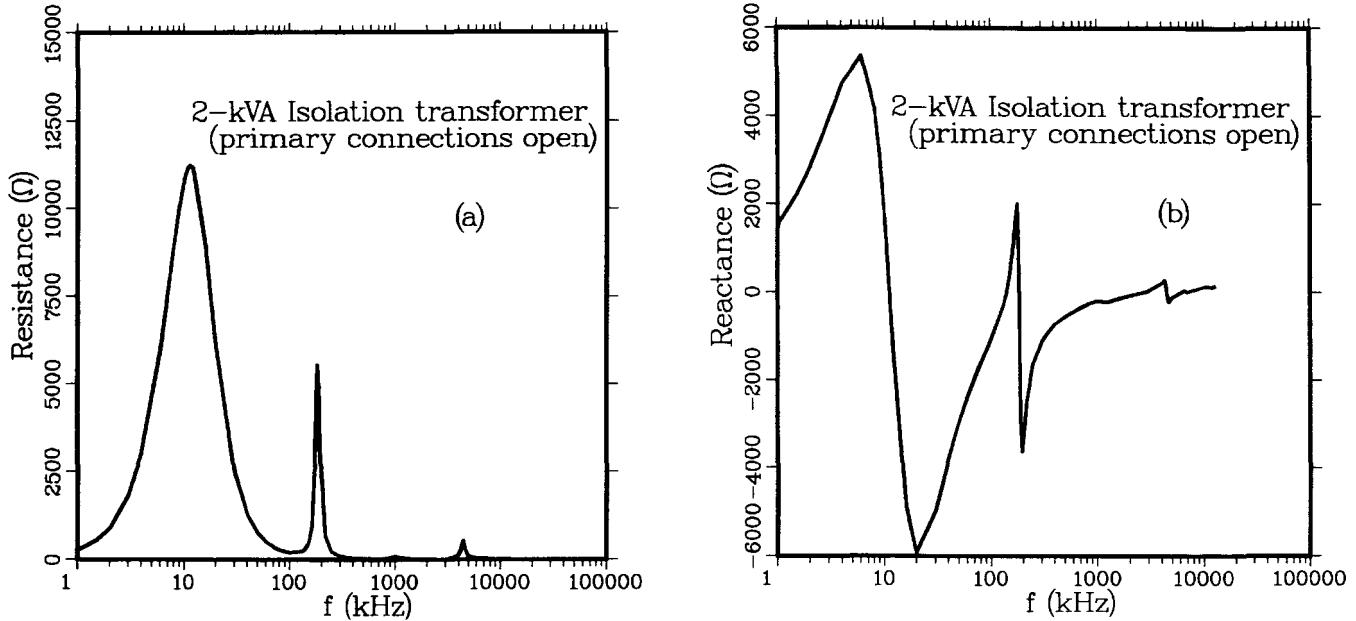
Figure A-1. Real (a) and imaginary (b) parts of impedance of the secondary winding, with the primary connections open

The transformer has identification markings: Westinghouse WP 17932-B, Style 1566974-D. Measurements of the real and imaginary portions of the secondary impedance are illustrated in Figures A-1 to A-2. The data were taken by N. I. Turner at Sandia National Laboratories, with a Hewlett Packard Model 4192A Impedance Analyzer. The data were recorded at room temperature, not at the usual transformer operating temperature.

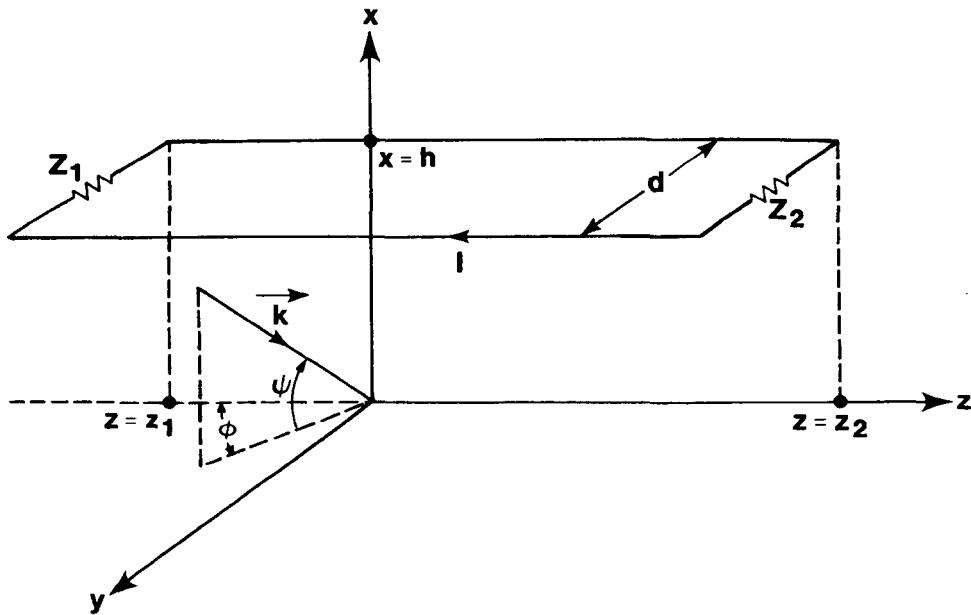
Figure B-1. Incident-wave geometry for the transmission line

Consistent with our transmission-line assumptions that allow neglect of the vector-potential time variation, the line voltage at position z is given by

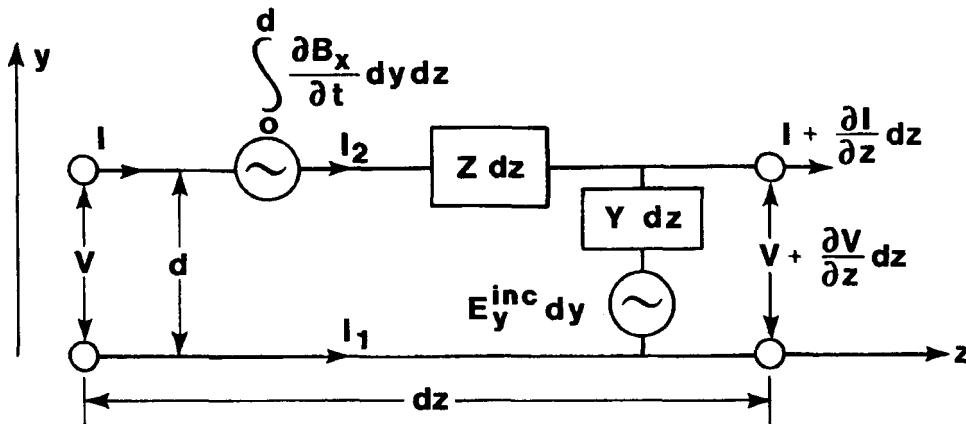
Figure B-2. Circuit diagram for a section of the transmission line

Z_1^i is the intrinsic impedance per unit length for each of the two wires in the line. As indicated by Taylor et al.,^{B-3} the differential-mode current is retrieved by letting $I_2 = I_c + I$, $I_1 = I_c - I$, $Z^i = 2Z_1^i$ so that

$$\partial V/\partial z + Z^i I = \partial/\partial t \int_0^d B_x(y,z) dy.$$
